CONSTRUCTION PRODUCTIVITY ADVANCEMENT RESEARCH (CPAR) PROGRAM

Cavitation- and Erosion-Resistant Thermal Spray Coatings

Jeffrey H. Boy, Ashok Kumar, Patrick March, Paul Willis, and Herbert Herman

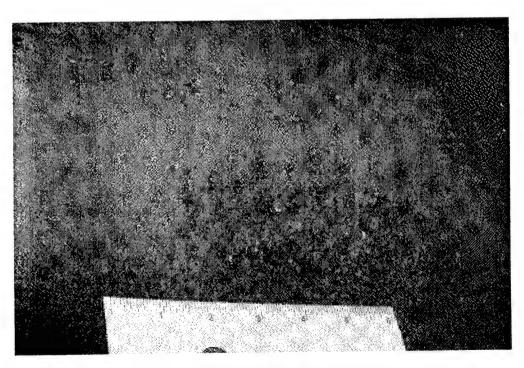
The formation and collapse of vapor bubbles or cavities in a fluid can produce extremely high pressures, frequently damaging adjacent surfaces and causing material loss (March and Hubble 1996). An example of cavitation damage observed on a Francis hydroelectric turbine located at the TVA Raccoon Mountain pumped-storage plant, Chattanooga, TN, is shown in Figure 1.

Figure 1. Cavitation damage on a TVA hydroelectric turbine blade.

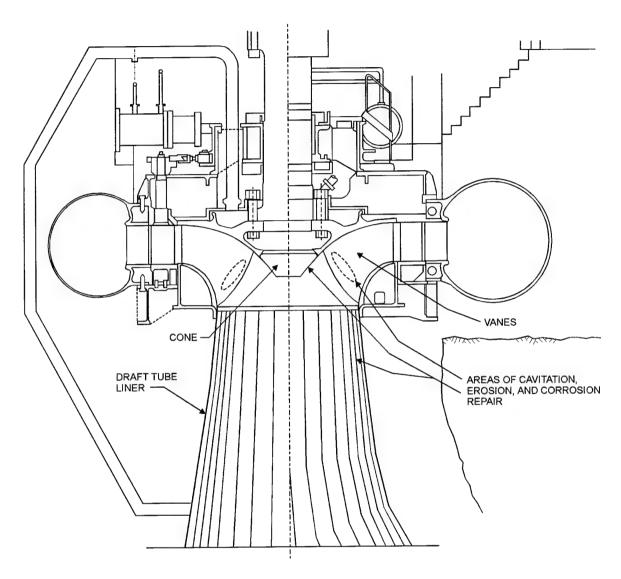
Figure 8. Schematic of hydroelectric pump/turbine at Raccoon Mountain showing where HVOF coatings were applied.

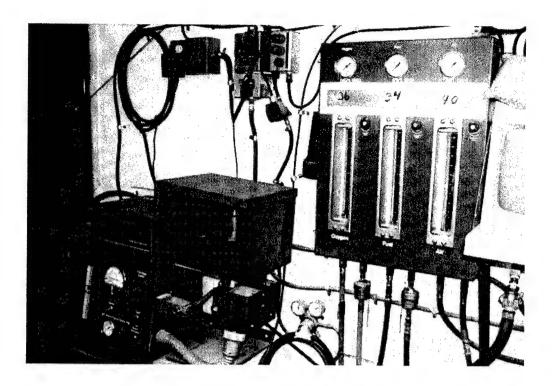
Figure 9. Thermal spray powder feed and gas flow control systems mounted in a mobile field trailer.

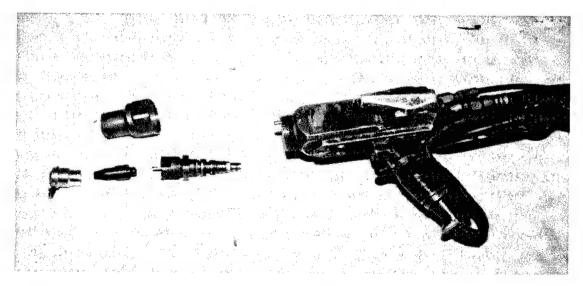
Figure 10. HVOF gun used in the field demonstration.

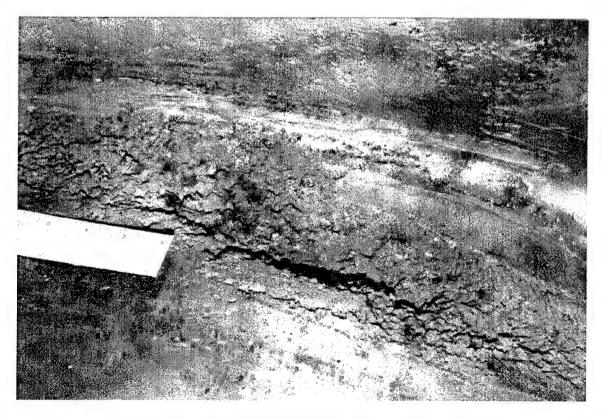
Severe cavitation damage at a runner crown/vane intersection of the turbine is shown in Figure 11. The condition of the turbine cone is shown in Figure 12. The area coated included an area near the base of the cone which had been repaired by welding 308 stainless steel and an area above this that was carbon steel. The weld repair was done by TVA personnel prior to start of the demonstration. The same area of the cone is shown in Figure 13 after the Stellite® 6 was successfully applied by HVOF thermal spray process. Tribaloy® T-400 and Stellite® 6 were also successfully applied to the draft tube liner and turbine vanes by HVOF. The surface of the turbine vanes had been weld-repaired with Hydroloy® 914 while the draft tube liner was the original carbon steel. Problems reported by Lontz (1992) with the field application of HVOF coatings were not experienced during this field demonstration.

Figure 11. Severe cavitation at a vane/crown intersection on a Francis pump/turbine at the Raccoon Mountain plant.

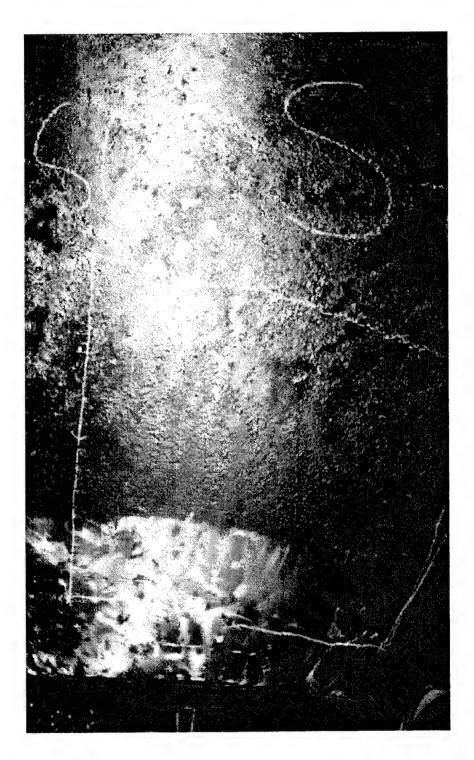
Figure 12. Cavitation and corrosion on the cone of a Francis pump/turbine at the Raccoon Mountain plant.

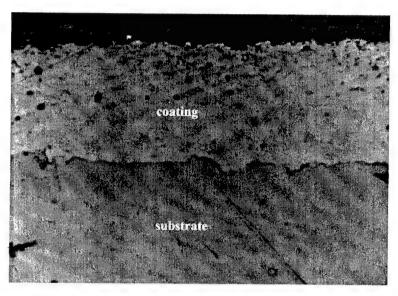
During the field demonstration, the technician grit blasted and thermally sprayed 1/8 in. thick steel test panels. These panels were taken back to the laboratory where metallographic samples were prepared. The optical micrographs of the Stellite® 6 and T-400 are shown in Figures 14 and 15. The micrographs show good bonding at the interface between the substrate and the coating and very little porosity in the coating near the substrate (see Figure 14).

Figure 14. Micrograph of HVOF Stellite® 6 coating (20 mil) steel test panel showing decreasing porosity at the coating/substrate interface.

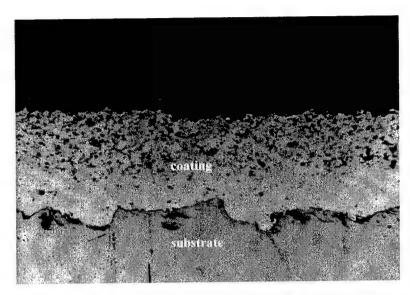
Both the Stellite® 6 and Tribaloy® T-400 coatings showed decreasing porosity in the coating from the coating surface to the coating/substrate interface. Greater porosity was observed in the Tribaloy® T-400 micrographs as compared to the Stellite® 6 (see Figure 15). This graduated porosity may decrease the cavitation resistance of the coating compared to a uniformly dense coating. Interconnected porosity could conceivably provide a continuous path through which water may reach the substrate. The presence of water at the coating/substrate interface may cause corrosion. However, the porosity in the sample field coatings was low near the substrate, and no continuous path was evident.

Figure 15. Micrograph of HVOF Tribaloy® T-400 coating (20 mil) on steel test panel showing good anchor profile at the coating/substrate interface.
